**Flood Control Project Maintenance
Levee Inspections**

Fall 2015 Levee Maintenance Deficiency Summary Report

Sacramento River Basin

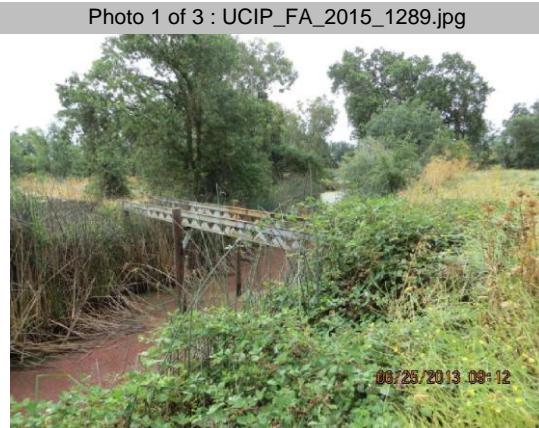
LM Start	1.72	Rating **	U	Issue No.	921	
LM End	1.72	Issue Type +	En	Location *	LS	
Category	Supplemental			GPS Latitude/Longitude		
				Start	End	
Item	DWR UCIP Field Study			38.480097 °	38.480097 °	
				-121.580844 °	-121.580844 °	
DWR ID						
Action/Comments						
Inspector Comments: FS_ID:39764 DS_ID:22743 EP_NO: N/A FS_HLM: 1.742 Repair Type: Urgent Crossing Status: Found UCIP Comments: Pipe abandoned and open on WS slope. Pipe should be abandoned properly. FIELD_STRUCT_DESC: 30-inch pipe through levee 6.5 feet below crown. Pump missing from platform in canal off LS toe. Flap gate on the waterward end. Siphon breaker and air vent on the landward shoulder. 1-inch galvanized iron filler pipe visible at WS shoulder along same alignment. Originally included in the 1966 O&M manual. FS Date: 06/25/2013

Pump platform visible off LS toe, but no appurtenances remain.

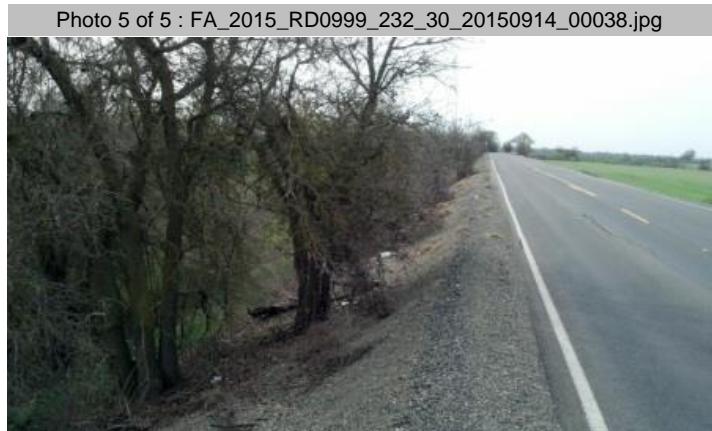
LM Start	1.79	Rating **	M	Issue No.	30 (cont)												
LM End	2.04	Issue Type +	Ma	Location *	LS												
Category	Earthen Levee			GPS Latitude/Longitude													
				Start	End												
Item	Trim / Thin Trees		38.479165 °	38.475463 °													
			-121.580640 °	-121.580722 °													
DWR ID	DWR_RD0999_01_s_2012_30																
Action/Comments																	
Trim trees to at least five feet above ground level.

Looking southeast at dense trees on landside slope and toe. (2013)

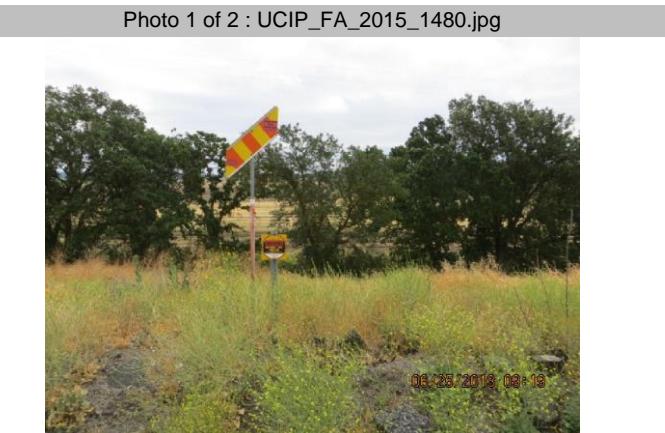
LM Start	2.09	Rating **	M	Issue No.	922									
LM End	2.09	Issue Type +	En	Location *	LS									
Category	Supplemental			GPS Latitude/Longitude										
				Start	End									
Item	DWR UCIP Field Study		38.474783 °	38.474783 °										
			-121.580428 °	-121.580428 °										
DWR ID														
Action/Comments														
Inspector Comments: FS_ID:16324 DS_ID:23957 EP_NO: N/A FS_HLM: 2.109 Repair Type: Non-Urgent Crossing Status: Found UCIP Comments: Need to determine permit for this crossing. FIELD_STRUCT_DESC: 20-inch steel gasoline through the levee at an unknown depth. Gasline markers on both shoulders. (Permit No. 16311, 1996) FS Date: 06/25/2013

Gasline marker on LS shoulder.

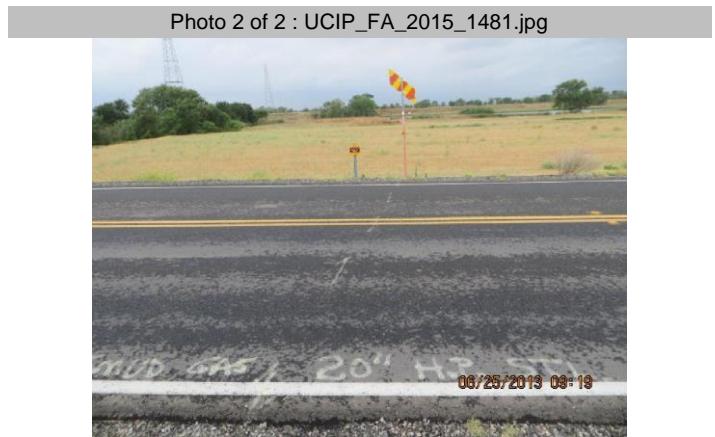
LM Start	2.09	Rating **	M	Issue No.	922 (cont)									
LM End	2.09	Issue Type +	En	Location *	LS									
Category	Supplemental			GPS Latitude/Longitude										
				Start	End									
Item	DWR UCIP Field Study			38.474783 °	38.474783 °									
				-121.580428 °	-121.580428 °									
DWR ID														
Action/Comments														
Inspector Comments: FS_ID:16324 DS_ID:23957 EP_NO: N/A FS_HLM: 2.109 Repair Type: Non-Urgent Crossing Status: Found UCIP Comments: Need to determine permit for this crossing. FIELD_STRUCT_DESC: 20-inch steel gasline through the levee at an unknown depth. Gasline markers on both shoulders. (Permit No. 16311, 1996) FS Date: 06/25/2013

Gasline markers on WS shoulder with USAA paint on roadway.

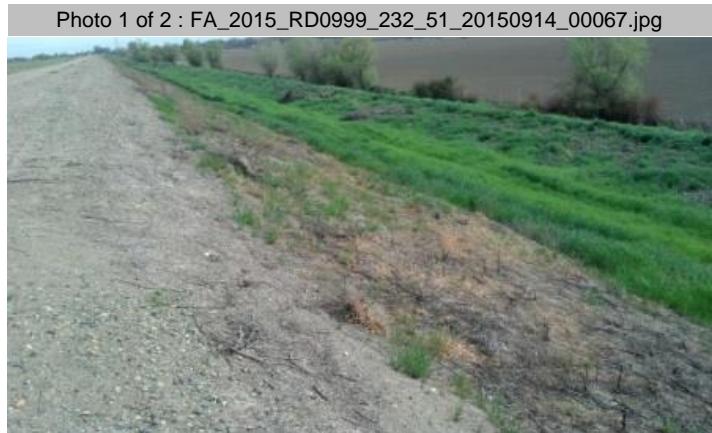
LM Start	3.24	Rating **	M	Issue No.	51													
LM End	3.26	Issue Type +	Ma	Location *	LS													
Category	Earthen Levee			GPS Latitude/Longitude														
				Start	End													
Item	Slope Stability				°		°		°									
DWR ID	DWR_RD0999_01_s_2013_51																	
Action/Comments																		
Repair slope instability. Inspector Comments: Depression on waterside shoulder and slope 60' x 20'. Earthen material appears to be sliding toward levee toe.

Looking north at depression on landside shoulder and slope.

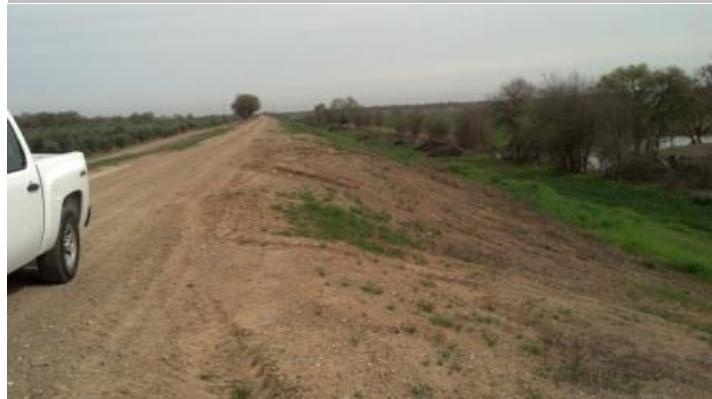
Photo 3 of 4 : FA_2015_RD0999_232_35_20150914_00044.jpg

LM Start	4.31	Rating **	M	Issue No.	35										
LM End	4.31	Issue Type +	Ma	Location *	LS										
Category	Earthen Levee			GPS Latitude/Longitude											
				Start	End										
Item	Slope Stability			38.444561 °	38.444561 °										
				-121.594438 °	-121.594438 °										
DWR ID	DWR_RD0999_01_f_2012_35														
Action/Comments															
Repair the levee slope damaged by vehicle traffic and prevent access where possible. Inspector Comments: Depression is caused by vehicle traffic.

Looking north at slope damage caused by vehicle traffic.

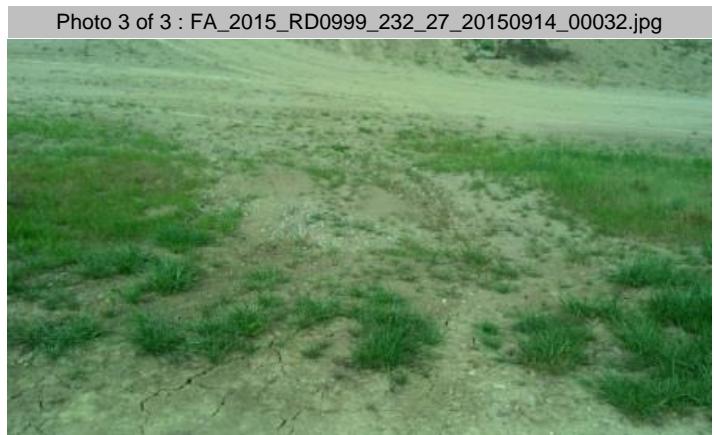
LM Start	4.31	Rating **	M	Issue No.	27 (cont)															
LM End	4.31	Issue Type +	Ma	Location *	WS															
Category	Earthen Levee			GPS Latitude/Longitude																
				Start	End															
Item	Slope Stability			38.444560 °	38.444560 °															
				-121.594440 °	-121.594440 °															
DWR ID	DWR_RD0999_01_f_2012_27																			
Action/Comments																				
Repair the levee slope damaged by vehicle traffic and prevent access where possible. Inspector Comments: Local farmer causing slope damage by driving equipment and trucks on slope.

Looking west at slope damage on waterside slope. (Spring 2014)

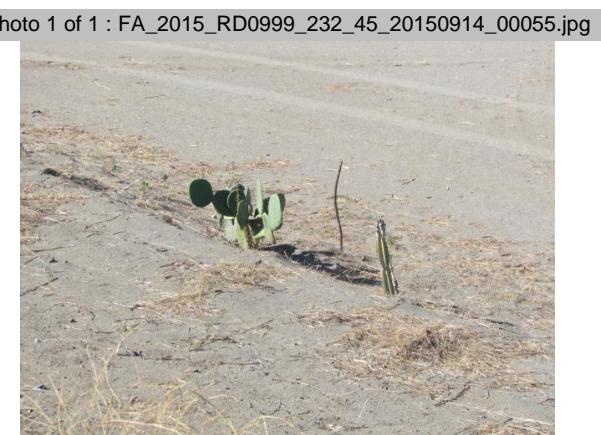
LM Start	4.36	Rating **	A/W	Issue No.	45															
LM End	4.36	Issue Type +	Ma	Location *	WS															
Category	Earthen Levee			GPS Latitude/Longitude																
				Start	End															
Item	Vegetation			°	°															
				°	°															
DWR ID	DWR_RD0999_01_f_2013_45																			
Action/Comments																				
Remove the wild growth other than native grasses from the levee slopes. Inspector Comments: Landowner has planted cactus on waterward toe.

Looking west at cactus on waterward toe.

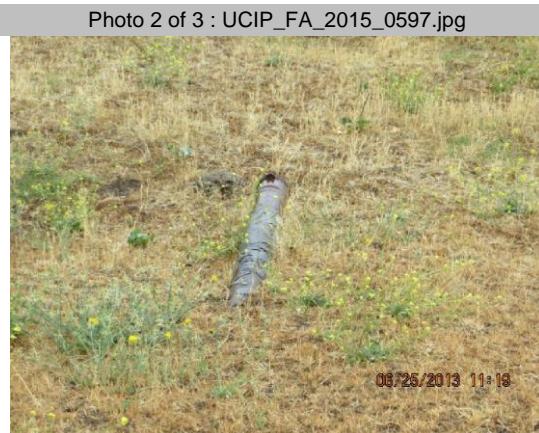
LM Start	9.50	Rating **	M	Issue No.	923 (cont)												
LM End	9.50	Issue Type +	En	Location *	CR												
Category	Supplemental				GPS Latitude/Longitude												
					Start	End											
Item	DWR UCIP Field Study				38.373823 °	38.373823 °											
DWR ID					-121.627212 °	-121.627212 °											
Action/Comments																	
Inspector Comments: FS_ID:24413 DS_ID:22750 EP_NO: 13300 FS_HLM: 9.519 Repair Type: Non-Urgent Crossing Status: Found UCIP Comments: Pipe abandoned and should be done so properly. FIELD_STRUCT_DESC: 6-inch steel pipe through the levee 3.0 feet below the crown. JP and meter at abandoned pump location on LS toe (Permit No. 13300, 1983). FS Date: 06/25/2013

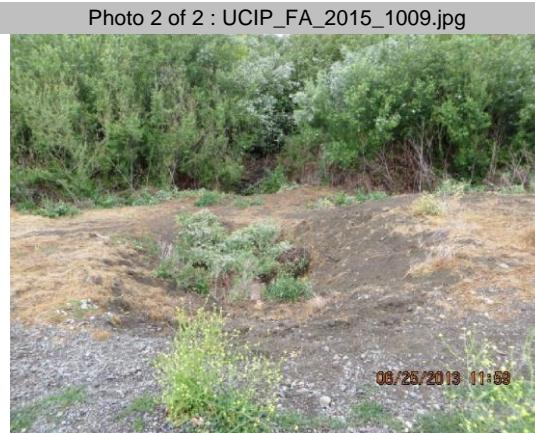
LM Start	12.28	Rating **	U	Issue No.	925 (cont)									
LM End	12.28	Issue Type +	En	Location *	CR									
Category	Supplemental			GPS Latitude/Longitude										
				Start	End									
Item	DWR UCIP Field Study			38.335834 °	38.335834 °									
				-121.643977 °	-121.643977 °									
DWR ID														
Action/Comments														
Inspector Comments: FS_ID:41785 DS_ID:22752 EP_NO: 11735 FS_HLM: 12.293 Repair Type: Urgent Crossing Status: Found UCIP Comments: Appears abandoned. Pipe exposed in cut on WS slope and open at LS toe. No pump or appurtenances. FIELD_STRUCT_DESC: 24-inch steel pipe through the levee 7.0 feet below the crown. Pump in drain ditch on the landward side with a sheetpile headwall. Flap gate on the waterward end. Siphon breaker in riser on the landward slope (Permit No. 11735, 1978). Replaced an existing pipe. FS Date: 06/25/2013

Pipe visible in exposed cut on WS slope.

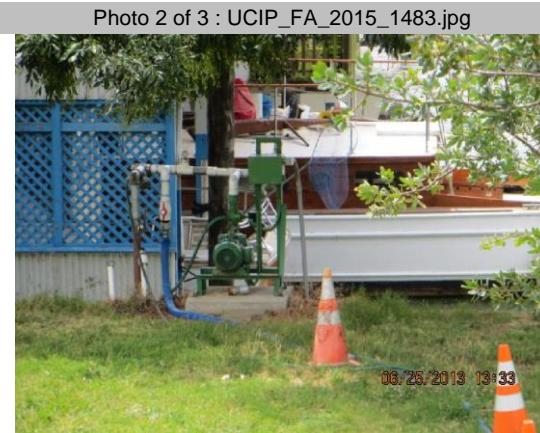
LM Start	15.36	Rating **	M	Issue No.	927 (cont)																			
LM End	15.36	Issue Type +	En	Location *	LS																			
Category				GPS Latitude/Longitude																				
				Start	End																			
Item				38.291192 °	38.291192 °																			
				-121.644987 °	-121.644987 °																			
DWR ID																								
Action/Comments																								
Inspector Comments: FS_ID:16330 DS_ID:23970 EP_NO: N/A FS_HLM: 15.374 Repair Type: Non-Urgent Crossing Status: Found UCIP Comments: No permit identified for this crossing. FIELD_STRUCT_DESC: 4-inch PVC waterline through the levee 2-feet below the crown. Pump off WS toe visible at waters edge. FS Date: 06/25/2013

Possible pump visible off WS toe at waters edge.

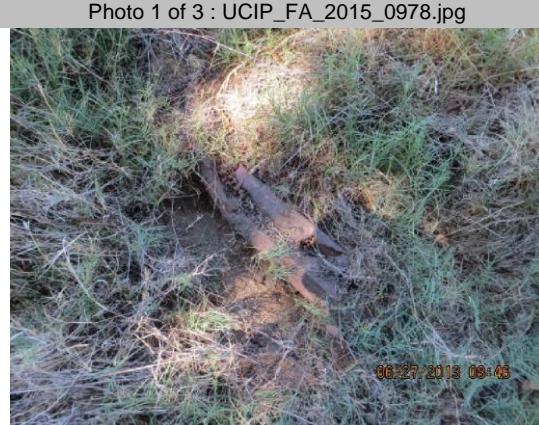
LM Start	0.79	Rating **	M	Issue No.	45	Action/Comments						
LM End	0.79	Issue Type +	En	Location *	WS							
Category	Supplemental				GPS Latitude/Longitude							
					Start	End						
Item	DWR UCIP Field Study				38.292562 °	38.292562 °						
					-121.631331 °	-121.631331 °						
DWR ID												
Inspector Comments: FS_ID:15384 DS_ID:22772 EP_NO: N/A FS_HLM: 0.78 Repair Type: Non-Urgent Crossing Status: Found UCIP Comments: Pipe open on both ends. Pumphouse has been removed. Needs to be abandoned properly. FIELD_STRUCT_DESC: "Abandoned" 8-inch pipe through levee 4.5 feet below crown. Abandoned pump house on the waterward slope. Originally included in the 1966 O&M manual. FS Date: 06/27/2013

Damaged pipe on LS slope.

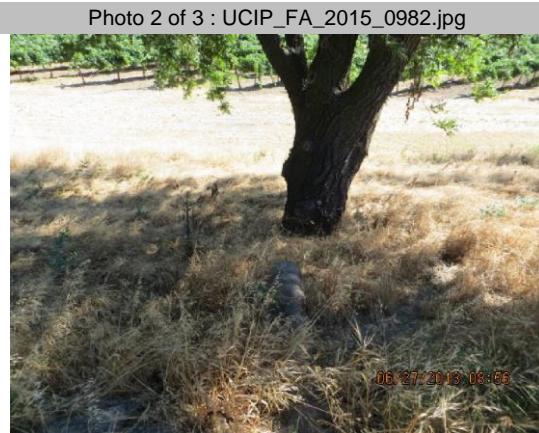
LM Start	0.93	Rating **	M	Issue No.	46 (cont)									
LM End	0.93	Issue Type +	En	Location *	LS									
Category	Supplemental			GPS Latitude/Longitude										
				Start	End									
Item	DWR UCIP Field Study			38.291739 °	38.291739 °									
				-121.628873 °	-121.628873 °									
DWR ID														
Action/Comments														
Inspector Comments: FS_ID:15385 DS_ID:22773 EP_NO: N/A FS_HLM: 0.93 Repair Type: Non-Urgent Crossing Status: Found UCIP Comments: Pipe should be abandoned properly. FIELD_STRUCT_DESC: *Abandoned* 10-inch steel irrigation pipe through levee 4.9 feet below crown. Capped on both ends. Originally included in the 1966 O&M manual. FS Date: 06/27/2013

Pipe with welded steel plate over end visible on LS

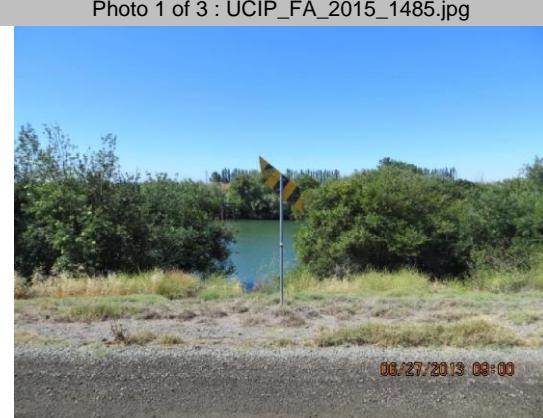
LM Start	1.02	Rating **	M	Issue No.	47		Photo 1 of 3 : UCIP_FA_2015_1485.jpg													
LM End	1.02	Issue Type +	En	Location *	LS															
Category	Supplemental			GPS Latitude/Longitude																
				Start	End															
Item	DWR UCIP Field Study			38.291252 °	38.291252 °															
				-121.627398 °	-121.627398 °															
DWR ID																				
Action/Comments																				
Inspector Comments: FS_ID:16331 DS_ID:23961 EP_NO: N/A FS_HLM: 1.013 Repair Type: Non-Urgent Crossing Status: Found UCIP Comments: Need to determine permit for this crossing. FIELD_STRUCT_DESC: Gasline through the levee at an unknown depth. Markers on both shoulders. FS Date: 06/27/2013

Gasline marker on WS shoulder.

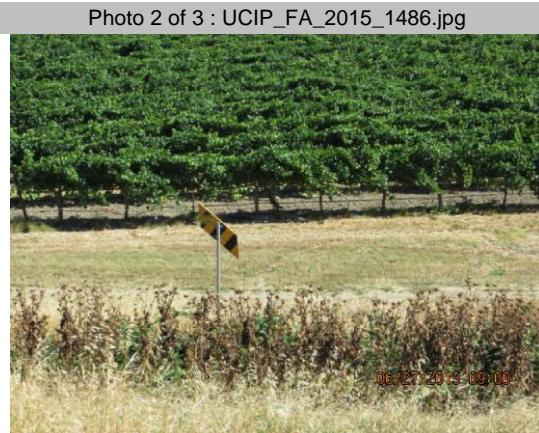
LM Start	1.02	Rating **	M	Issue No.	47 (cont)									
LM End	1.02	Issue Type +	En	Location *	LS									
Category	Supplemental			GPS Latitude/Longitude										
				Start	End									
Item	DWR UCIP Field Study			38.291252°	38.291252°									
				-121.627398°	-121.627398°									
DWR ID														
Action/Comments														
Inspector Comments: FS_ID:16331 DS_ID:23961 EP_NO: N/A FS_HLM: 1.013 Repair Type: Non-Urgent Crossing Status: Found UCIP Comments: Need to determine permit for this crossing. FIELD_STRUCT_DESC: Gasline through the levee at an unknown depth. Markers on both shoulders. FS Date: 06/27/2013

Gasline marker on LS toe.

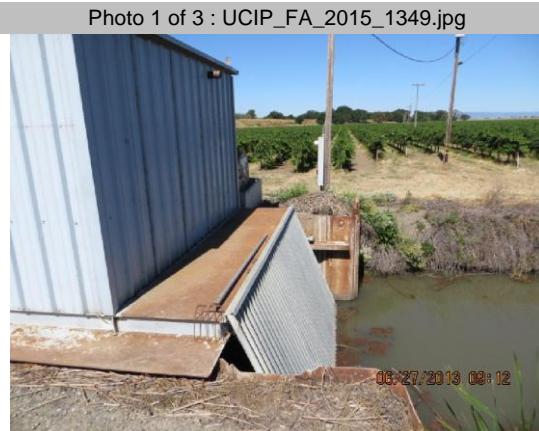
LM Start	1.25	Rating **	M	Issue No.	48 (cont)				
LM End	1.25	Issue Type +	En	Location *	LS

LM Start	1.25	Rating **	M	Issue No.	48																	
LM End	1.25	Issue Type +	En	Location *	LS																	
Category	Supplemental				GPS Latitude/Longitude																	
					Start	End																
Item	DWR UCIP Field Study				38.291379 °	38.291379 °																
					-121.623285 °	-121.623285 °																
DWR ID																						
Action/Comments																						
Inspector Comments: FS_ID:16333 DS_ID:23962 EP_NO: N/A FS_HLM: 1.239 Repair Type: Non-Urgent Crossing Status: Found UCIP Comments: Need to determine permit for this crossing. FIELD_STRUCT_DESC: 16-inch steel stormdrain through the levee 3-feet below the crown with a pump in a pumphouse on the LS toe. Siphon breaker in a 24-inch steel riser on WS. PN 17064, 1999. FS Date: 06/27/2013

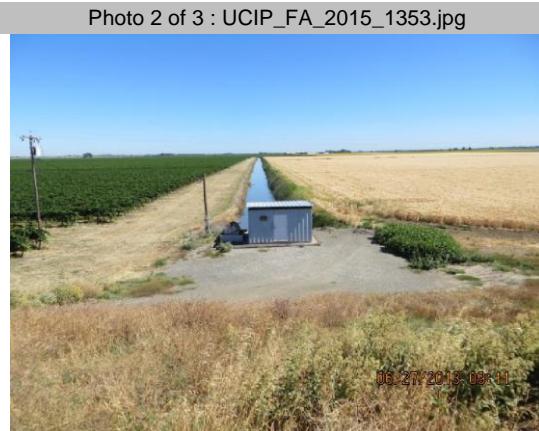
LM Start	1.25	Rating **	M	Issue No.	49 (cont)									
LM End	1.25	Issue Type +	En	Location *	LS									
Category	Supplemental			GPS Latitude/Longitude										
				Start	End									
Item	DWR UCIP Field Study			38.291381 °	38.291381 °									
				-121.623268 °	-121.623268 °									
DWR ID														
Action/Comments														
Inspector Comments: FS_ID:16334 DS_ID:23963 EP_NO: N/A FS_HLM: 1.241 Repair Type: Non-Urgent Crossing Status: Found UCIP Comments: Need to determine permit No. for this crossing. FIELD_STRUCT_DESC: 30-inch steel stormdrain through the levee 2.5-feet below the crown with a pump in a pumphouse on the LS toe. Siphon breaker in a 24-inch steel riser on WS. Permit No. 17064, 1999 FS Date: 06/27/2013

Pumphouse on LS toe.

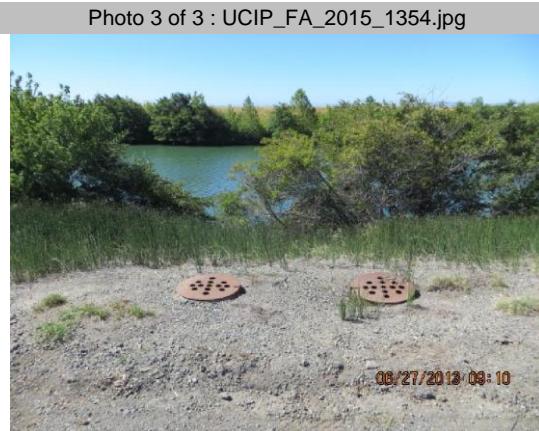
LM Start	1.25	Rating **	M	Issue No.	49 (cont)	
LM End	1.25	Issue Type +	En	Location *	LS

Siphon breaker on WS shoulder.

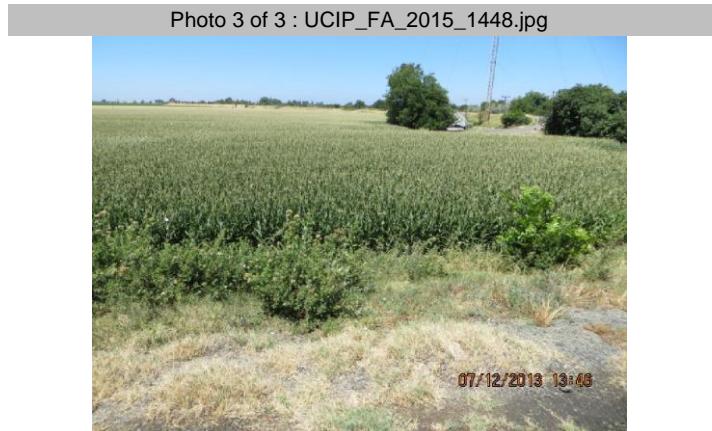
LM Start	2.27	Rating **	M	Issue No.	52 (cont)											
LM End	2.27	Issue Type +	En	Location *	LS											
Category	Supplemental			GPS Latitude/Longitude												
				Start	End											
Item	DWR UCIP Field Study			38.286666 °	38.286666 °											
				-121.606803 °	-121.606803 °											
DWR ID																
Action/Comments																
Inspector Comments: FS_ID:15703 DS_ID:22770 EP_NO: 3855 FS_HLM: 2.265 Repair Type: Non-Urgent Crossing Status: Found

Pipe visible just off shoulder on LS slope in the rose bushes.

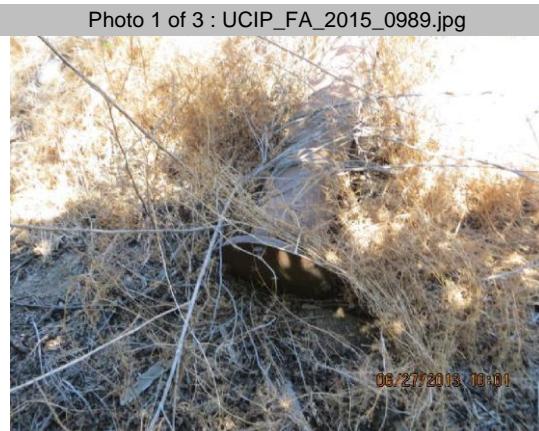
LM Start	0.18	Rating **	M	Issue No.	51							
LM End	0.18	Issue Type +	En	Location *	LS							
Category	Supplemental			GPS Latitude/Longitude								
				Start	End							
Item	DWR UCIP Field Study			38.288813 °	38.288813 °							
				-121.604670 °	-121.604670 °							
DWR ID												
Action/Comments												
Inspector Comments: FS_ID:15389 DS_ID:22776 EP_NO: N/A FS_HLM: 0.158 Repair Type: Non-Urgent Crossing Status: Found

Steel plate on WS end of pipe.

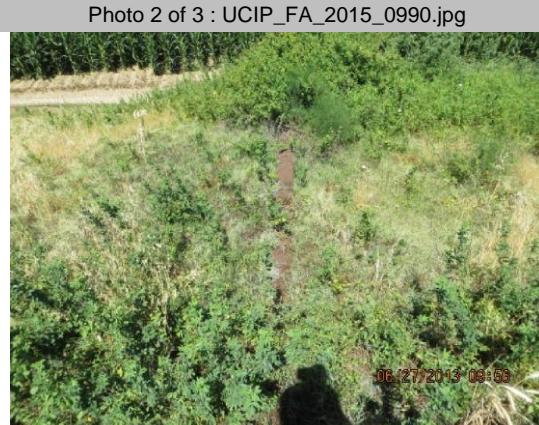
LM Start	0.18	Rating **	M	Issue No.	51 (cont)	
LM End	0.18	Issue Type +	En	Location *	LS

Pipe visible on LS slope.

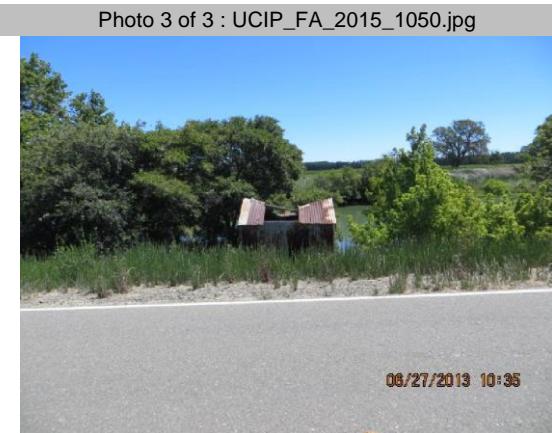
LM Start	1.71	Rating **	M	Issue No.	52 (cont)									
LM End	1.71	Issue Type +	En	Location *	LS									
Category	Supplemental			GPS Latitude/Longitude										
				Start	End									
Item	DWR UCIP Field Study			38.308513 °	38.308513 °									
				-121.598874 °	-121.598874 °									
DWR ID														
Action/Comments														
Inspector Comments: FS_ID:15392 DS_ID:22779 EP_NO: N/A FS_HLM: 1.702 Repair Type: Non-Urgent Crossing Status: Found

Pumphouse visible on WS slope.

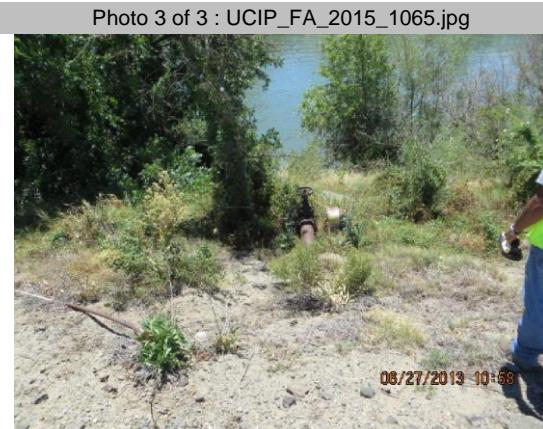
LM Start	2.00	Rating **	M	Issue No.	53 (cont)									
LM End	2.00	Issue Type +	En	Location *	LS									
Category	Supplemental			GPS Latitude/Longitude										
				Start	End									
Item	DWR UCIP Field Study			38.311709 °	38.311709 °									
				-121.596713 °	-121.596713 °									
DWR ID														
Action/Comments														
Inspector Comments: FS_ID:15393 DS_ID:22780 EP_NO: N/A FS_HLM: 2 Repair Type: Non-Urgent Crossing Status: Found

Pipe visible on WS slope.

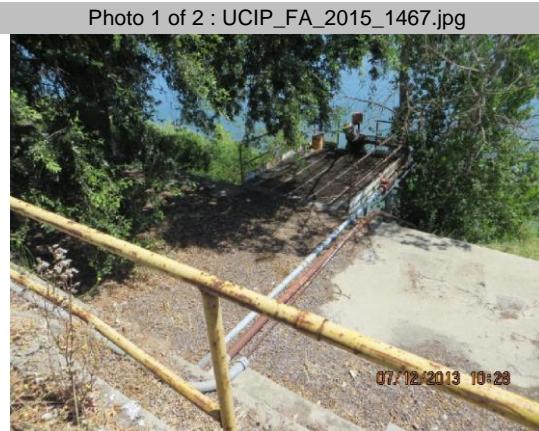
LM Start	0.74	Rating **	M	Issue No.	43																	
LM End	0.74	Issue Type +	En	Location *	LS																	
Category	Supplemental				GPS Latitude/Longitude																	
					Start	End																
Item	DWR UCIP Field Study				38.423418 °	38.423418 °																
					-121.529486 °	-121.529486 °																
DWR ID																						
Action/Comments																						
Inspector Comments: FS_ID:41535 DS_ID:22795 EP_NO: N/A FS_HLM: 0.737 Repair Type: Non-Urgent Crossing Status: Found

Electrical conduit shown at bottom of picture (pipe with 90-degree bend).

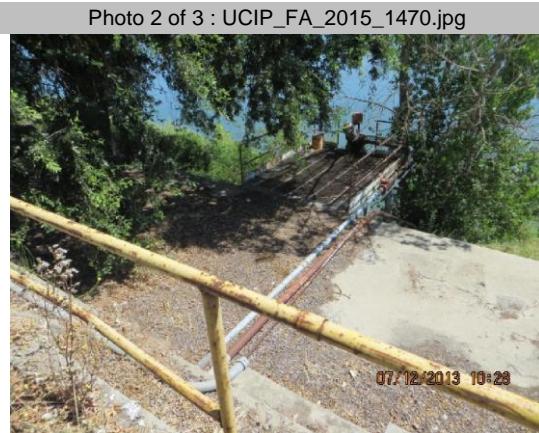
LM Start	0.74	Rating **	M	Issue No.	45 (cont)									
LM End	0.74	Issue Type +	En	Location *	LS									
Category	Supplemental			GPS Latitude/Longitude										
				Start	End									
Item	DWR UCIP Field Study			38.423429 °	38.423429 °									
				-121.529491 °	-121.529491 °									
DWR ID														
Action/Comments														
Inspector Comments: FS_ID:41070 DS_ID:22811 EP_NO: 10514 FS_HLM: 0.737 Repair Type: Non-Urgent Crossing Status: Found UCIP Comments: Need to determine disposition of pipe and if abandoned, it should be done so properly. FIELD_STRUCT_DESC: 2 of 3: 4.5-inch galvanized iron irrigation pipe through the levee 3.0 feet below the crown. Slant pump, steel walkway, and steel vent pipe on the waterward slope. Pipe has shutoff valve off LS toe (Permit No. 10514, 1974). FS Date: 07/12/2013

Pipe and slant pump on WS at concrete pad.

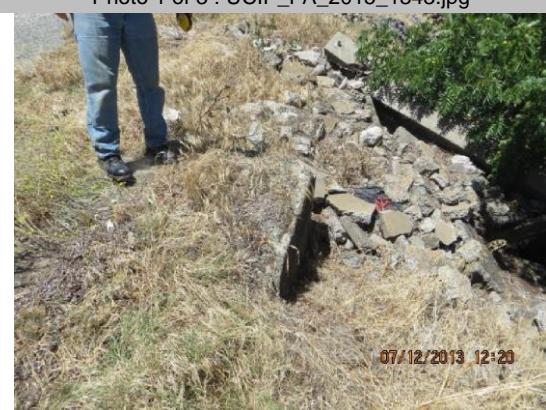
LM Start	0.90	Rating **	M	Issue No.	48		Photo 1 of 3 : UCIP_FA_2015_1343.jpg
LM End	0.90	Issue Type +	En	Location *	LS		
Category	Supplemental			GPS Latitude/Longitude			
				Start	End		
Item	DWR UCIP Field Study			38.425514	°	38.425514	°
				-121.530970	°	-121.530970	°
DWR ID							
Action/Comments							
Inspector Comments: FS_ID:15728 DS_ID:22806 EP_NO: N/A FS_HLM: 0.902 Repair Type: Non-Urgent Crossing Status: Found UCIP Comments: Pipe abandoned and should be done so properly. FIELD_STRUCT_DESC: 2 of 6: *Abandoned* 3.5-inch pipe through levee 2.5 feet below crown. Pipe visible in concrete well on LS shoulder and likely in covered concrete well on WS shoulder. FS Date: 07/12/2013

Assumed pipes are in concrete well on WS shoulder at same location.

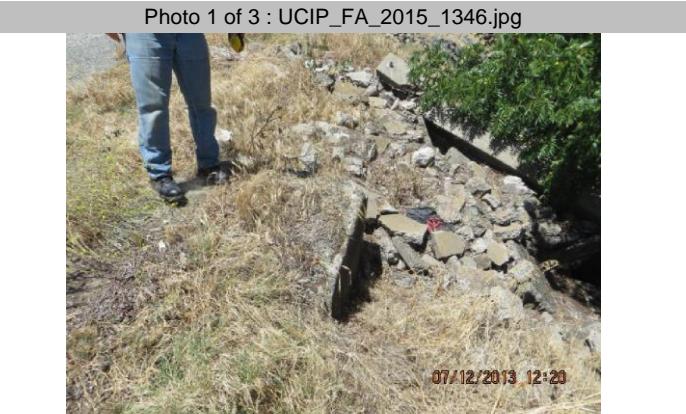
LM Start	0.90	Rating **	M	Issue No.	53 (cont)	
LM End	0.90	Issue Type +	En	Location *	LS

Pipe assumed visible in concrete well on WS shoulder.

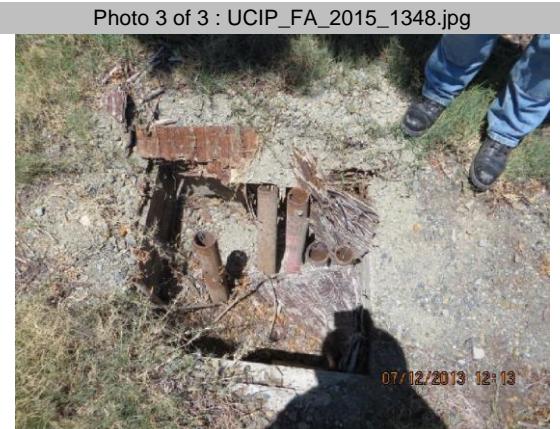
LM Start	0.90	Rating **	M	Issue No.	53 (cont)									
LM End	0.90	Issue Type +	En	Location *	LS									
Category	Supplemental			GPS Latitude/Longitude										
				Start	End									
Item	DWR UCIP Field Study			38.425514 °	38.425514 °									
				-121.530970 °	-121.530970 °									
DWR ID														
Action/Comments														
Inspector Comments: FS_ID:15733 DS_ID:22808 EP_NO: N/A FS_HLM: 0.902 Repair Type: Non-Urgent Crossing Status: Found

Pipe in concrete well on LS shoulder.

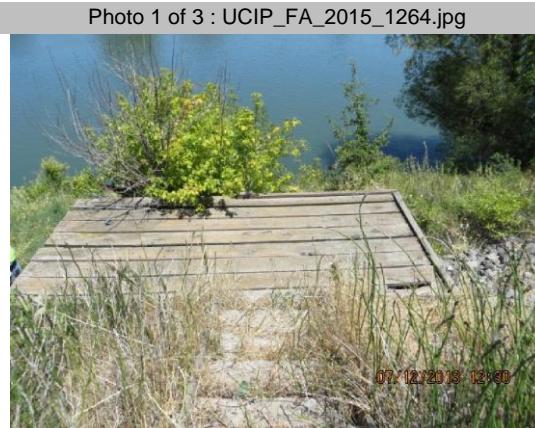
9'X18' concrete box with gatevalve on WS slope.

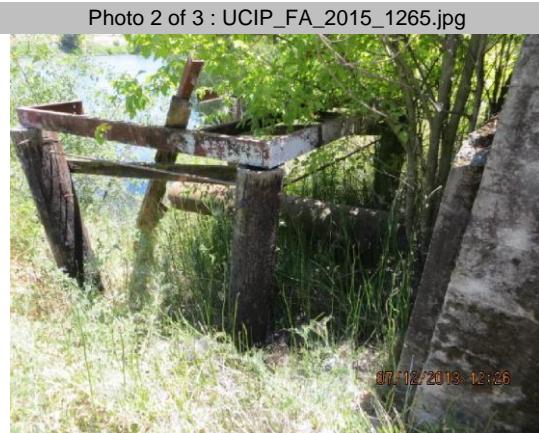
LM Start	1.00	Rating **	M	Issue No.	54 (cont)	
LM End	1.00	Issue Type +	En	Location *	LS

Slant pump missing from pier on WS slope.

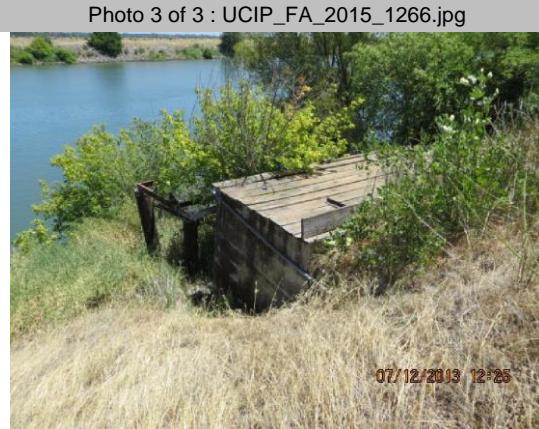
Slide gate in 9'X18' concrete box on WS slope.

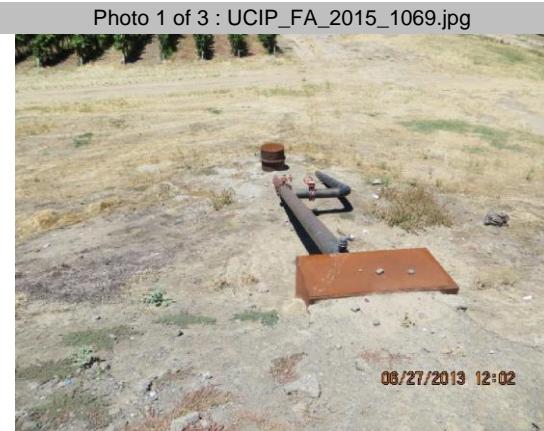
Steel junction box, vent, butterfly valve, and standpipe visible on LS slope.

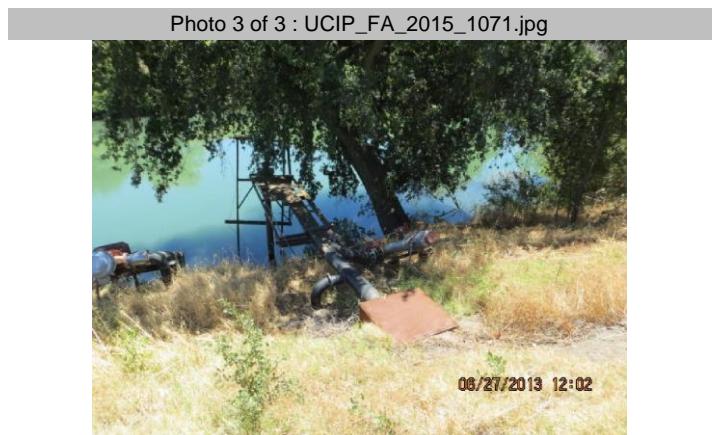
Pump and steel junction box visible on WS slope.

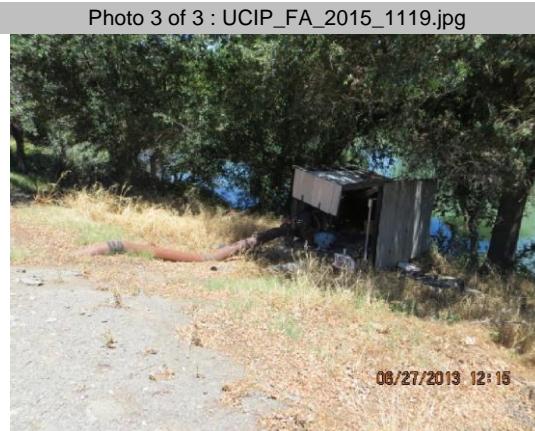
Pump in pumphouse on WSs slope.

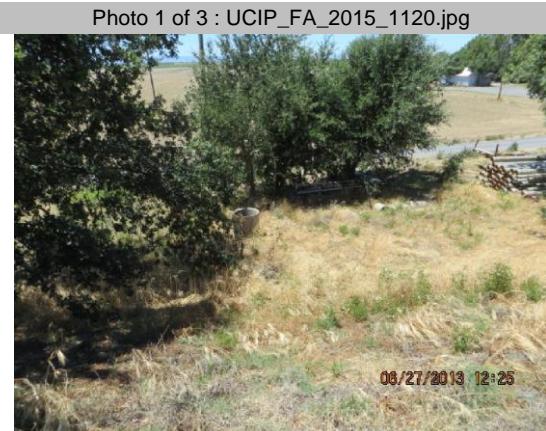
Pipe may be aligned with concrete standpipe at LS toe, but no pipe is visible on LS.

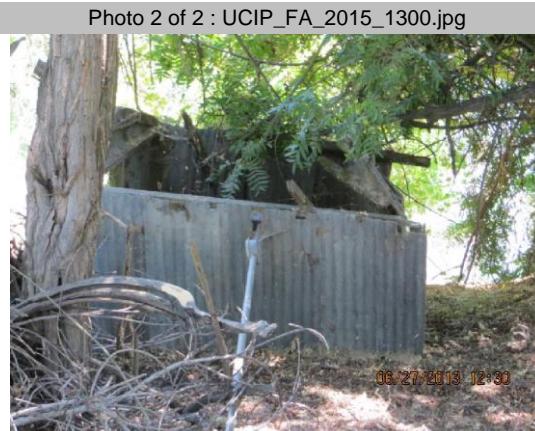
Pumphouse on WS slope with electrical conduit shown.

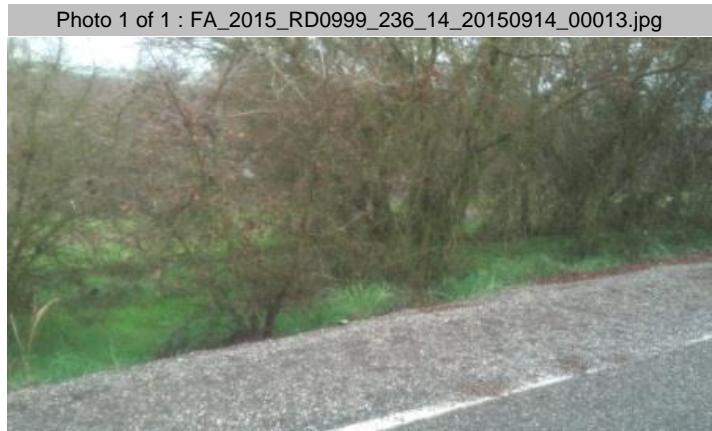
Looking west at dense trees on landside slope and toe.

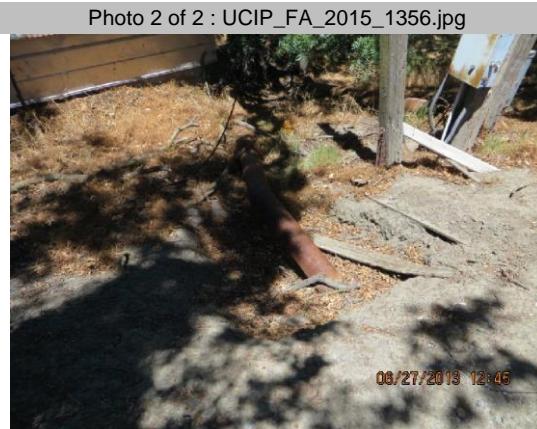
Pipe visible on LS shoulder.

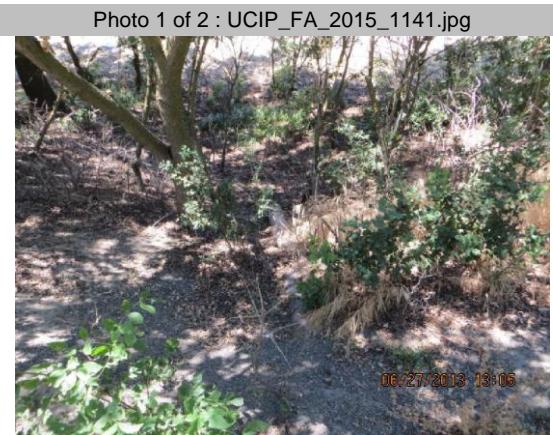
Pipe visible on LS slope.

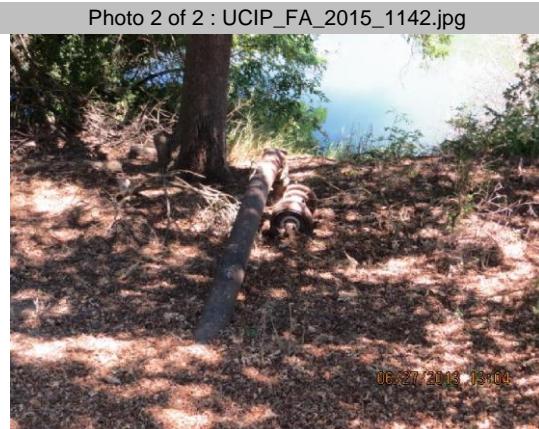
Pipe and pump remnants on WS slope.

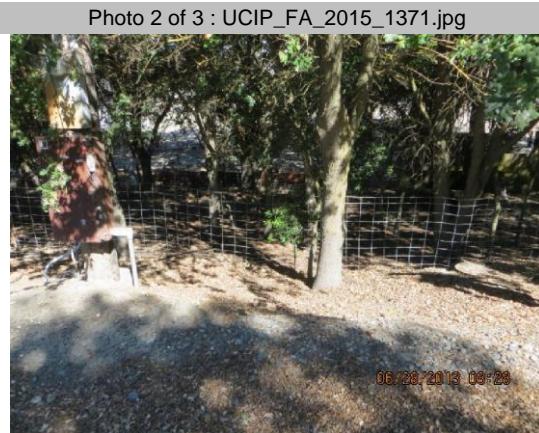
1.5-inch galvanized iron electrical conduit at same location.

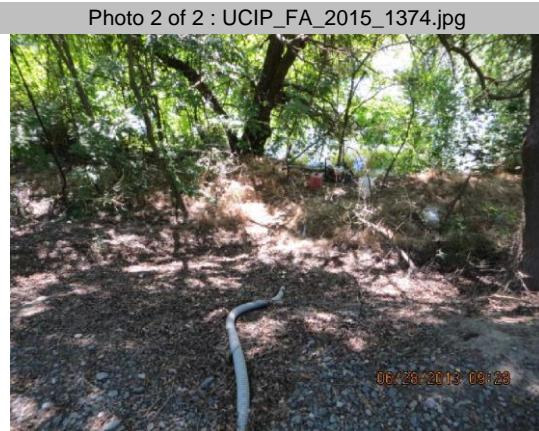
Flex pipe through the levee 6-inches below the crown with portable pump on WS toe.

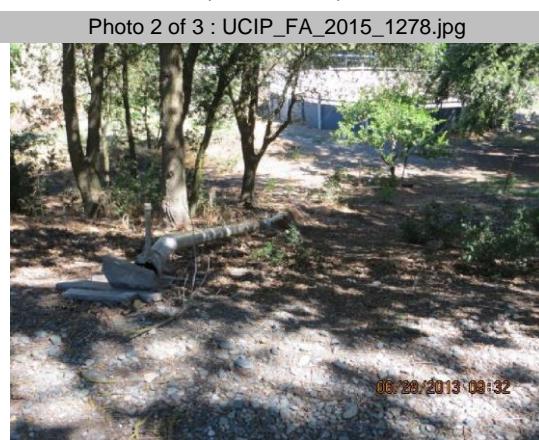
Pipe on WS slope.

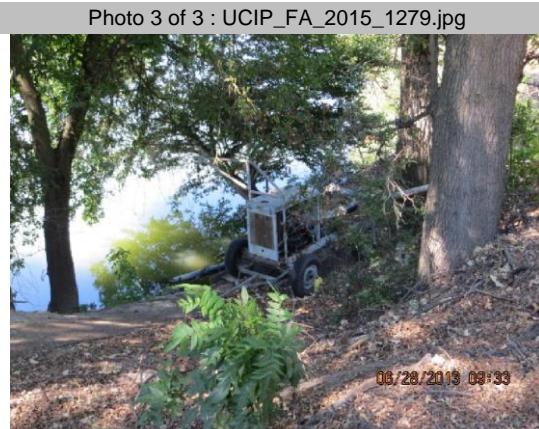
Portable pump on WS toe.

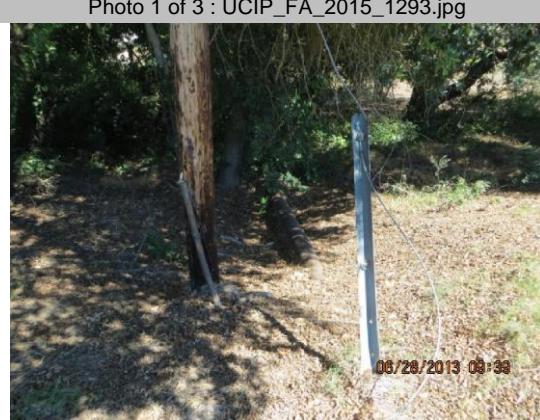
Pipe visible on LS slope.

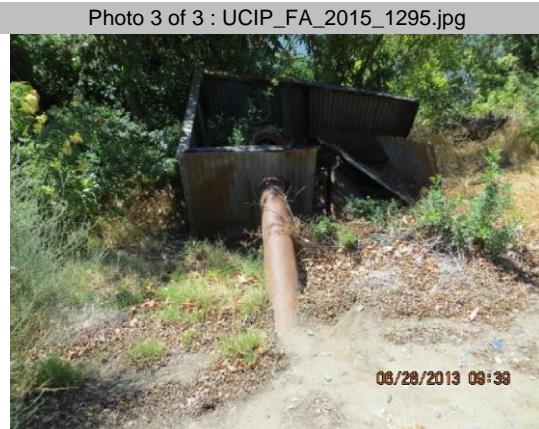
Abandoned pumphouse on WS slope.

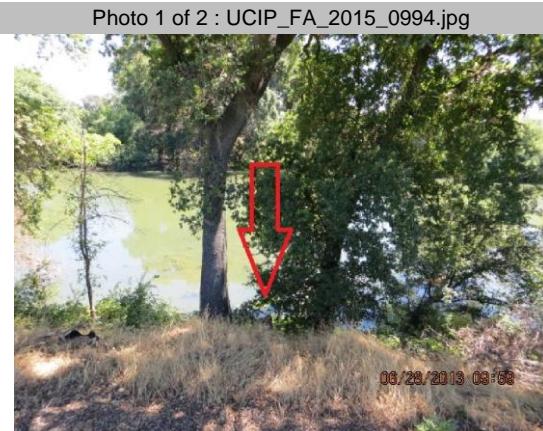
Pipe visible on WS slope.

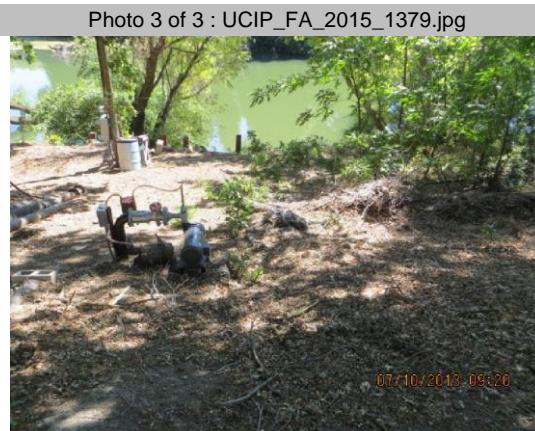
Pump on WS slope.

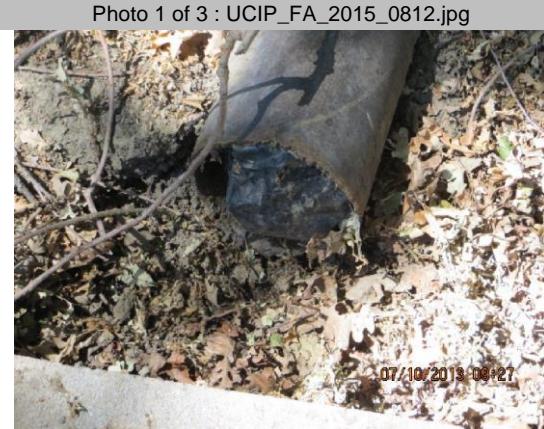
Pipe open on WS slope.

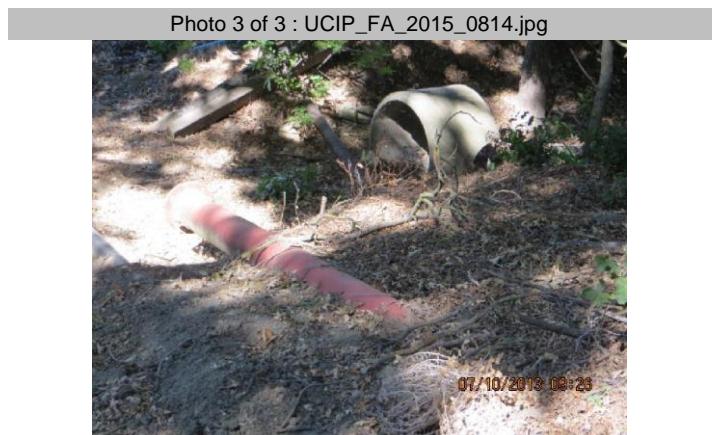
6-inch steel pipe on LS slope with evidence of 36-inch standpipe in background.

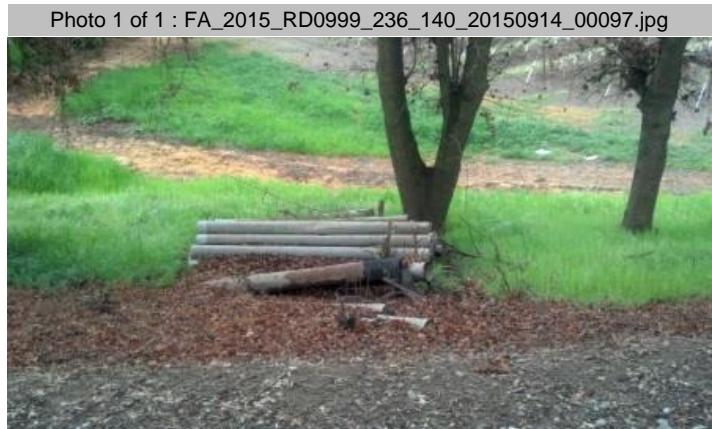
Looking west at irrigation pipes on landside toe.

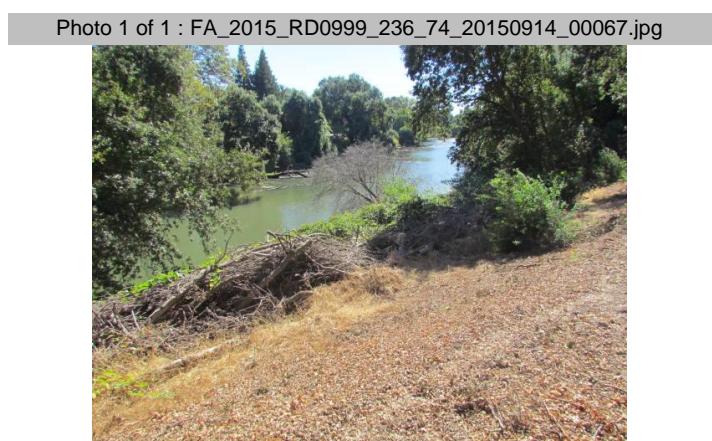
Looking southeast at prunings on waterward slope.

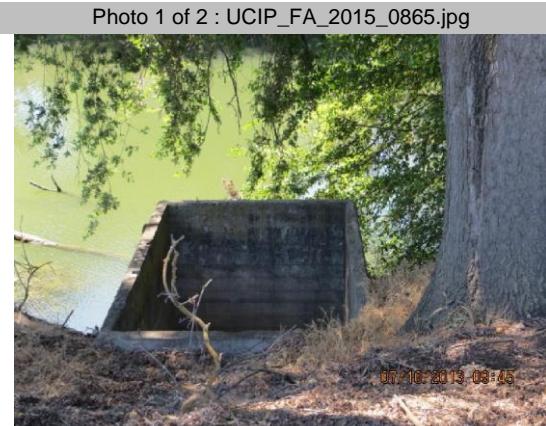
Concrete pump pit on WS slope.

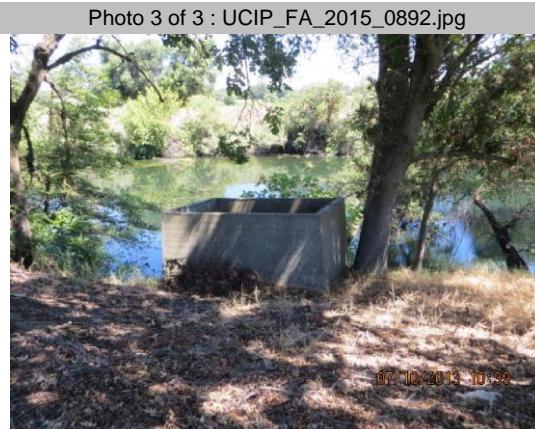
Concrete pump pit on WS toe.

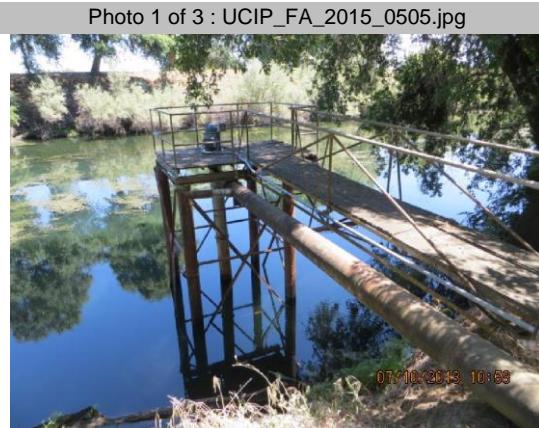
Pump on metal pier with walkway at WS toe

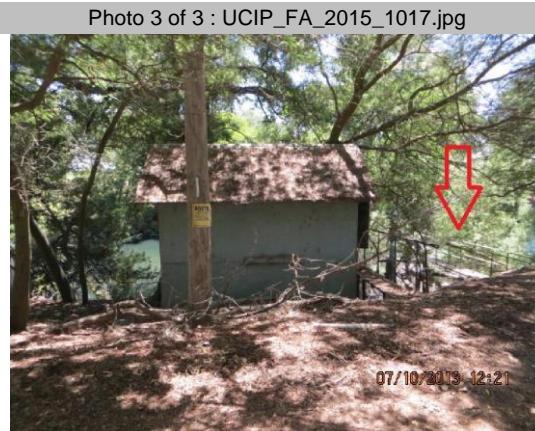
Pump on metal pier with walkway on WS slope.

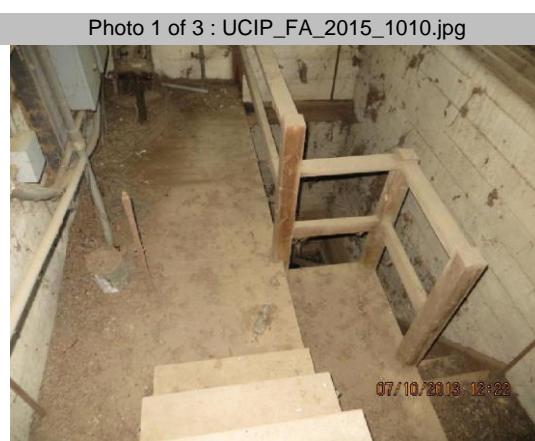
Pump and gate valve assumed to be in bottom of concrete well inside pumphouse.

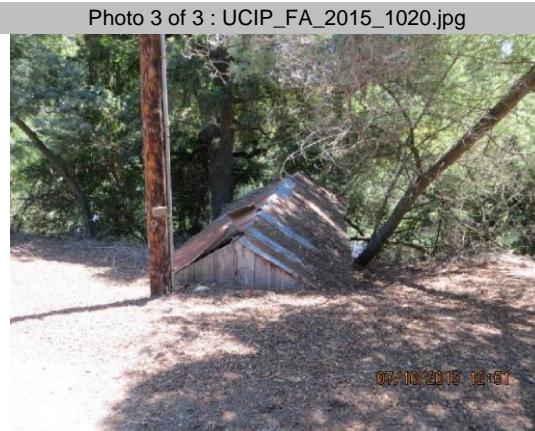
Pumphouse/concrete headwall on WS slope.

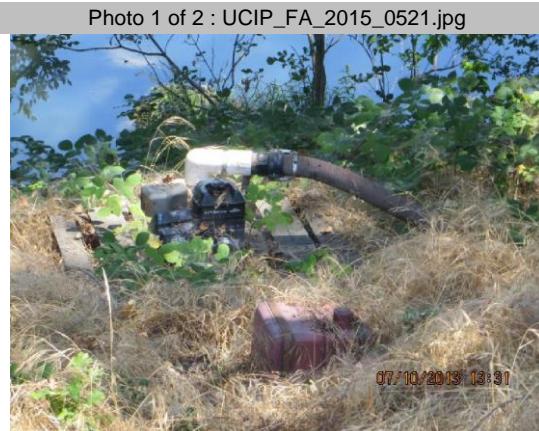
Portable pump on WS toe.
